Civil Aviation Organization of the  
Islamic Republic of Iran

## PS752 Accident Investigation

# FACTUAL REPORT

July 2020

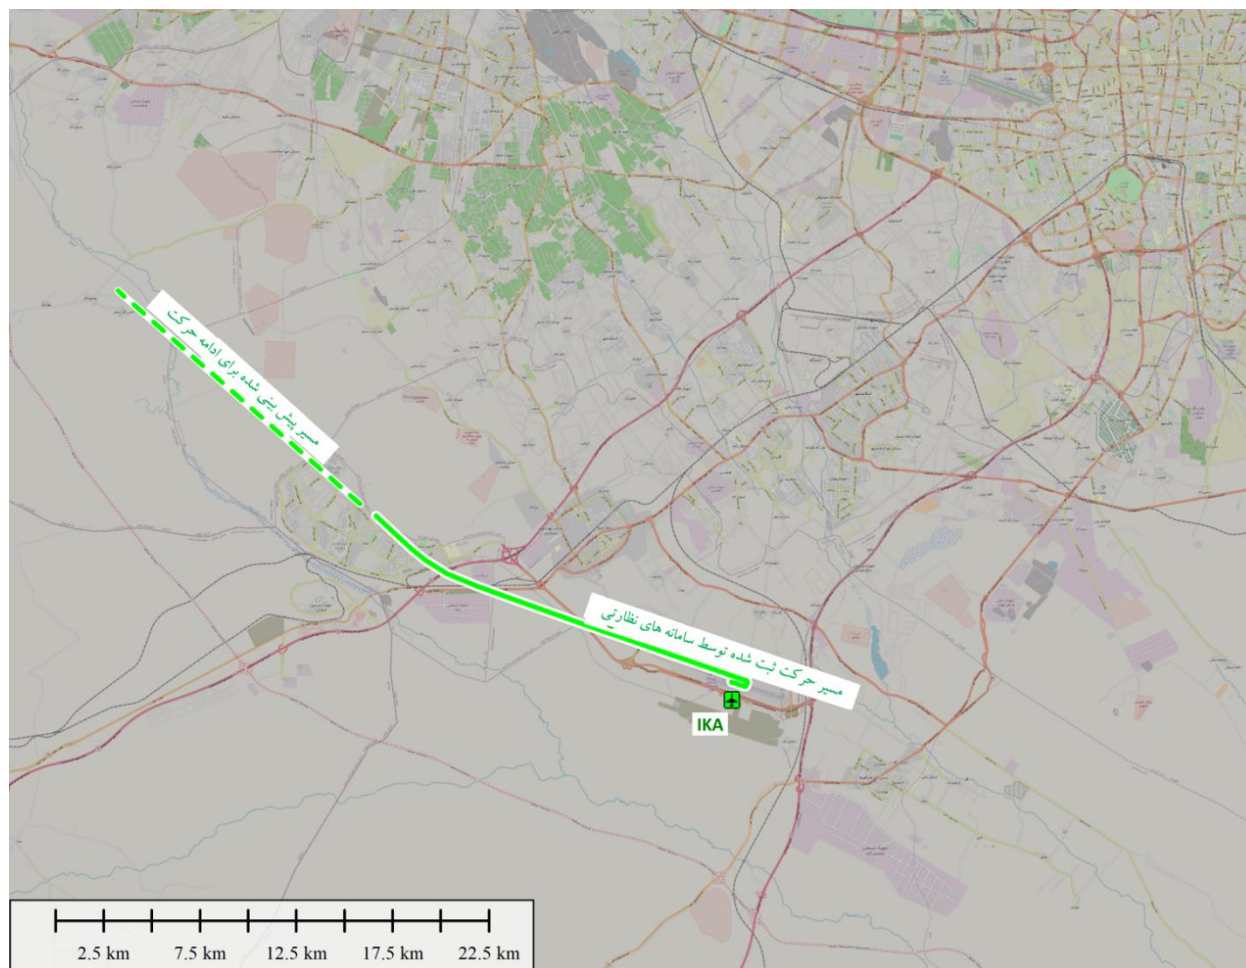
۶- پرواز در مسیر و ارتفاع پیش‌بینی شده به سمت کریدور پروازی ادامه حرکت داد (شکل ۱).

شکل ۱ - مسیر ثبت شده حرکت پرواز PS752

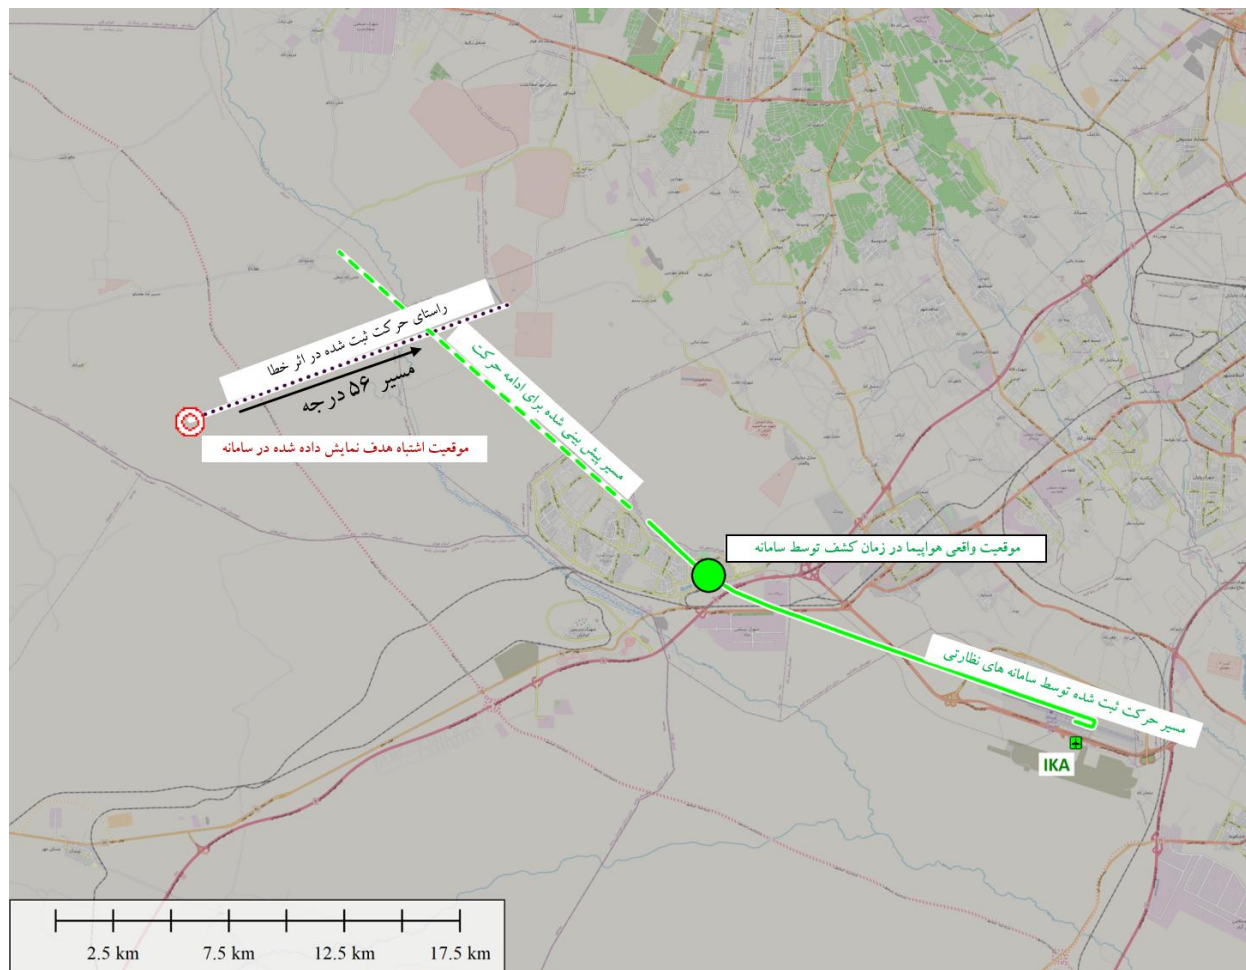
۷- <sup>۳</sup> در یکی از سامانه‌های دفاع هوایی تهران، پس از جابجایی سامانه که منجر به تغییر مکان جغرافیایی و سمت سامانه شده بود، فرآیند تنظیم مجدد راستای شمال سیستم در اثر خطای انسانی و اجرا نکردن مراحل الزامی بعد از جابجایی فراموش می‌شود. این سامانه به دلیل تنظیم نمودن صحیح مجدد شمال، دچار خطایی برابر با ۱۰۷ درجه می‌شود و در زمان پرواز هواپیمای اکراینی، سمت اهداف و اشیاء شناسایی شده توسط سامانه با افزایش برابر با ۱۰۷ درجه توسط کاربر سامانه دفاع هوایی مشاهده می‌شد. این رخداد، آغاز ایجاد

۹- کاربر سامانه دفاع هوایی مشخصات هدف شناسایی شده را در ساعت ۰۶:۱۴:۲۱ بر روی بستر ارتباطی به مرکز هماهنگی مربوطه اعلام نمود (در خصوص برقراری ارتباط به بند بعدی مراجعه شود). این هدف همان هواپیمای اکرائینی بوده که از سمت فرودگاه امام در حال نزدیک شدن به سامانه بوده است ولی توسط سامانه به عنوان هدفی که از ناحیه جنوب غربی در حال نزدیک شدن به تهران بود شناسایی می‌شود (شکل ۲).

شکل ۲ - موقعیت واقعی هواپیما در زمان کشف و موقعیت ثبت شده در سامانه

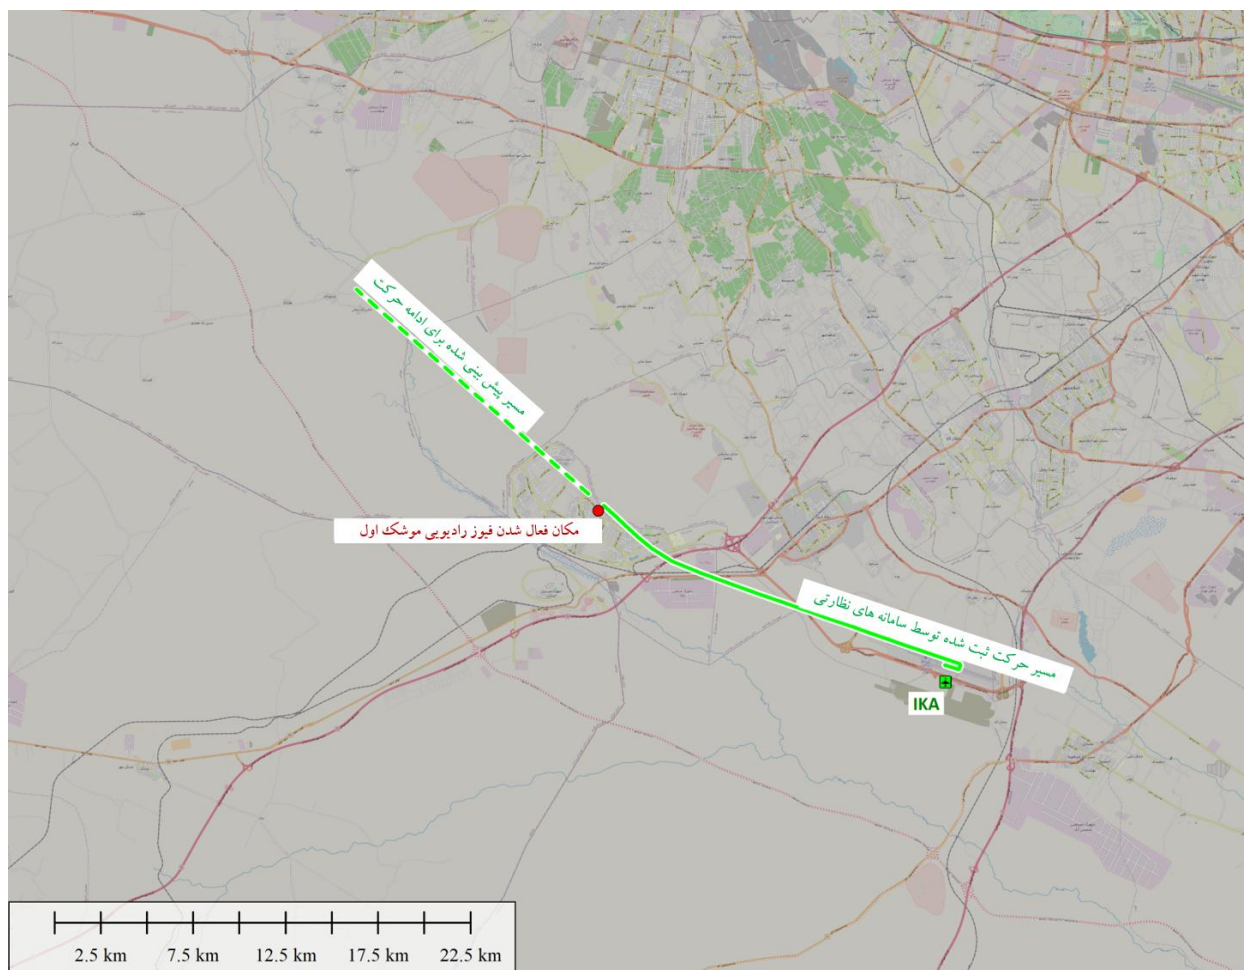
۱۴- فیوز رادیویی موشک شلیک شده در زمانی که هواپیما در آخرین موقعیت ثبت شده توسط سامانه‌های نظارتی وابسته<sup>۶</sup> رسیده بود در همان محل فعال می‌شود. این رخداد در زمان ۰۶:۱۴:۵۹ رخ داده است (شکل ۳).

شکل ۳ - موقعیت فعال شدن فیوز مجاورتی موشک اول

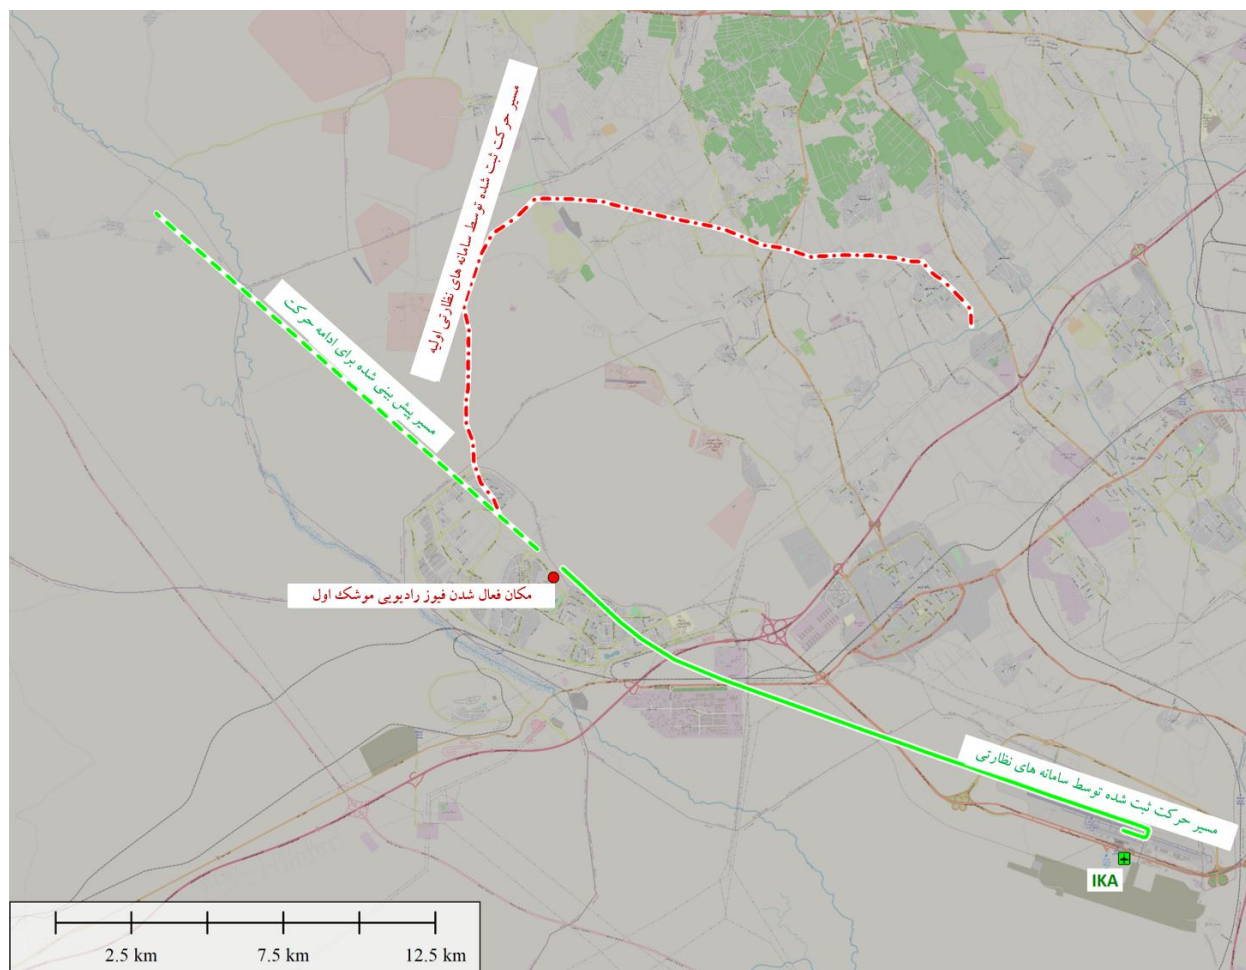
۱۵- در زمان ۰۶:۱۴:۵۸، آخرین اطلاعات دریافتی از هواپیما شامل ترانسپاندر رادار ثانویه هواپیما و اطلاعات خودکار موقعیتی موسوم به ADS-B دریافت و پس از آن، این اطلاعات قطع می شود. این زمان با زمان عمل کردن فیوز رادیویی موشک اول منطبق است. از این زمان به بعد، اطلاعات مسیر هواپیما تنها توسط سامانه نظارتی رادار اولیه<sup>۷</sup> ثبت می شود. این اطلاعات از روی بازتاب های راداری هواپیما ثبت شده است و هیچ نوع سیگنال رادیویی از هواپیما دریافت نشده است (شکل ۴).

شکل ۴- قطع ارتباطات هواپیما و ثبت ادامه مسیر از روی بازتاب های راداری

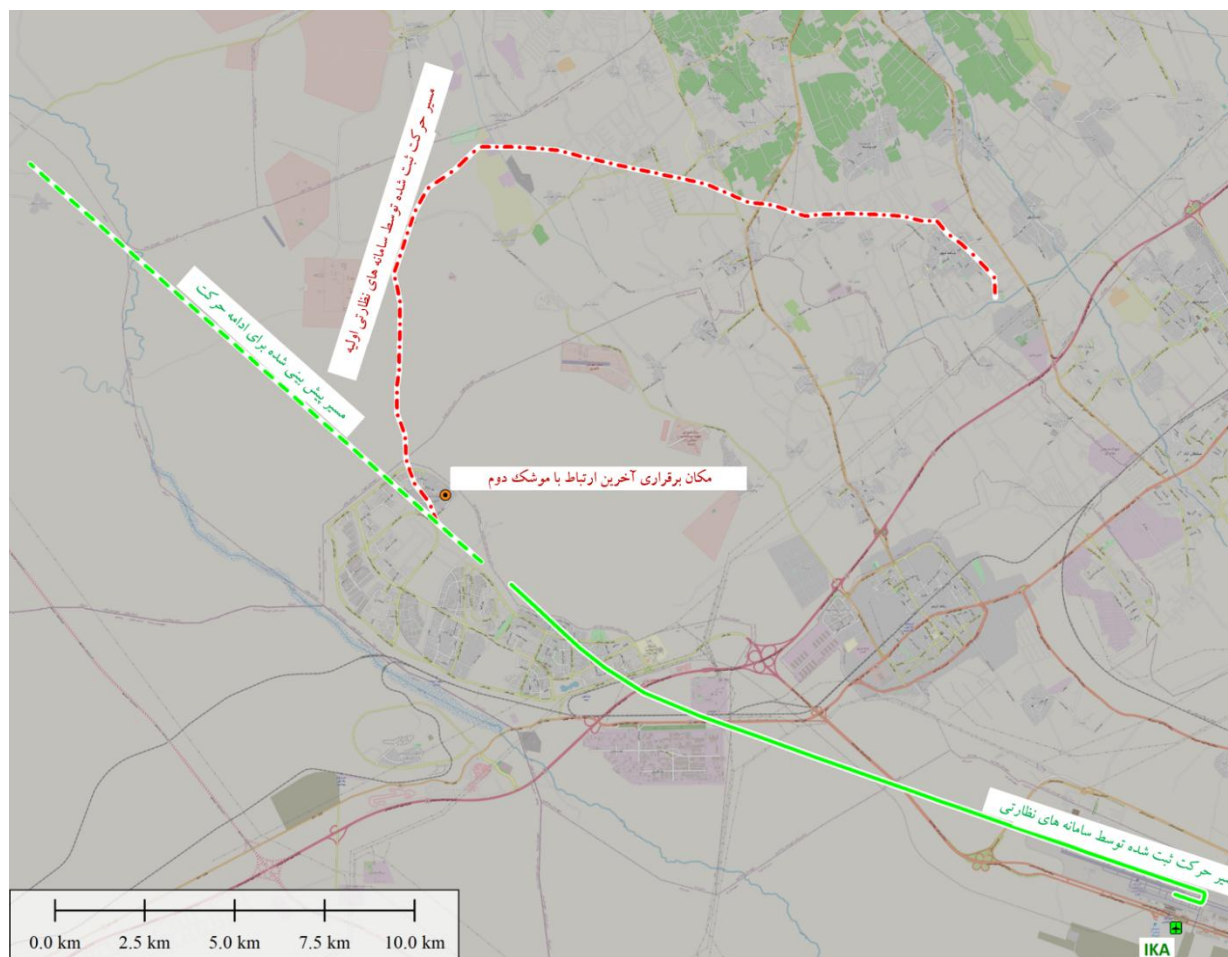
۱۸- آخرین ارتباط موشک با سامانه پدافندی در زمان ۰۶:۱۵:۲۴ در مکانی نزدیک مسیر حرکت هواپیما ثبت شده است. پس از آن، پیام موفقیت آمیز نبودن عملکرد موشک در سامانه نشان داده می شود و هواپیما پس از مدتی از قفل راداری سامانه خارج می شود (شکل ۵).

شکل ۵- مکان برقراری آخرین ارتباط با موشک دوم

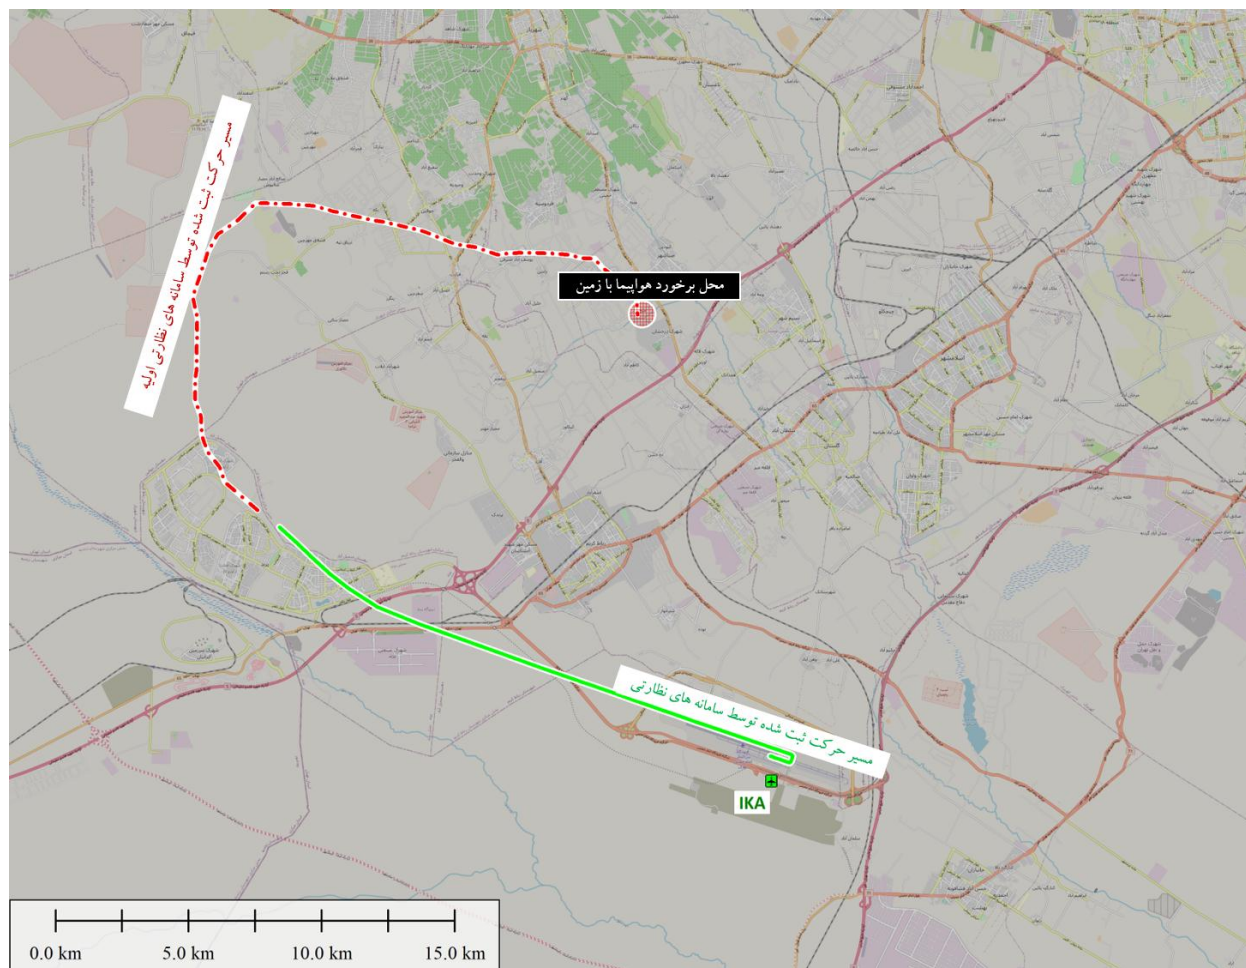
۲۱- هواپیما در ساعت ۰۶:۱۸:۲۳ و در منطقه خلیج آباد در نزدیکی شاهد شهر در موقعیت مشخص شده در شکل ۶ و در یک زمین بازی به زمین برخورد می کند. همزمان با برخورد هواپیما با زمین، انفجاری رخ می دهد و هواپیما در یک مسیر که به سمت فرودگاه قرار دارد در چند مرحله دیگر به زمین برخورد کرده و قطعات هواپیما، اموال و اشیاء جانباختگان و بقایای پیکر مسافران پرواز در ناحیه ای گسترده در یک منطقه مسکونی، پارک تفریحی و ورزشی و باغها و زمین های کشاورزی اطراف منتشر می شود.

شکل ۶ - محل برخورد هواپیما با زمین

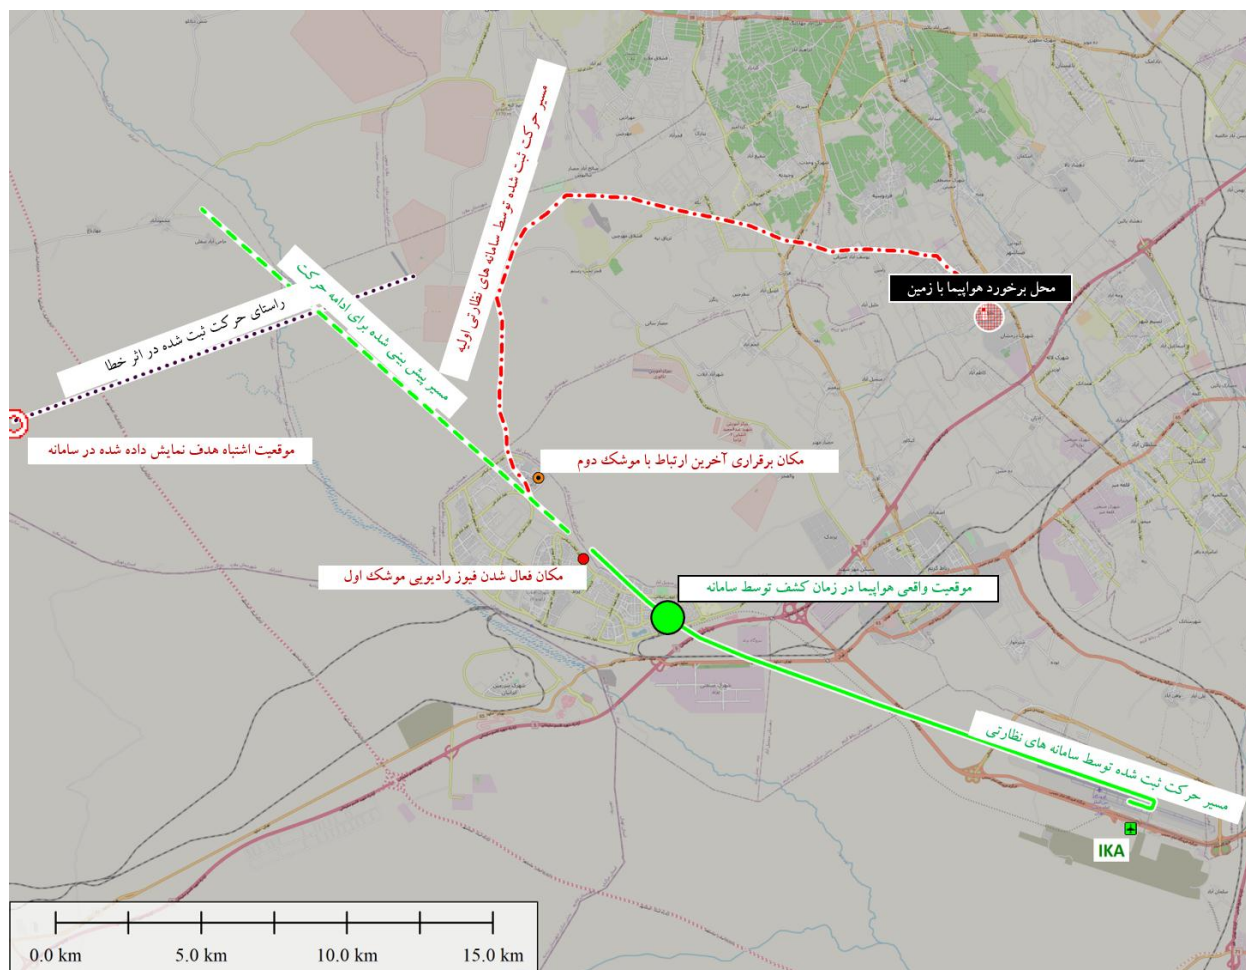
نمایشی کامل از اطلاعات و رویدادهای رخ داده در مسیر پرواز PS752 در شکل ۷ نشان داده شده است.

شکل ۷- نمایش کامل روند پرواز

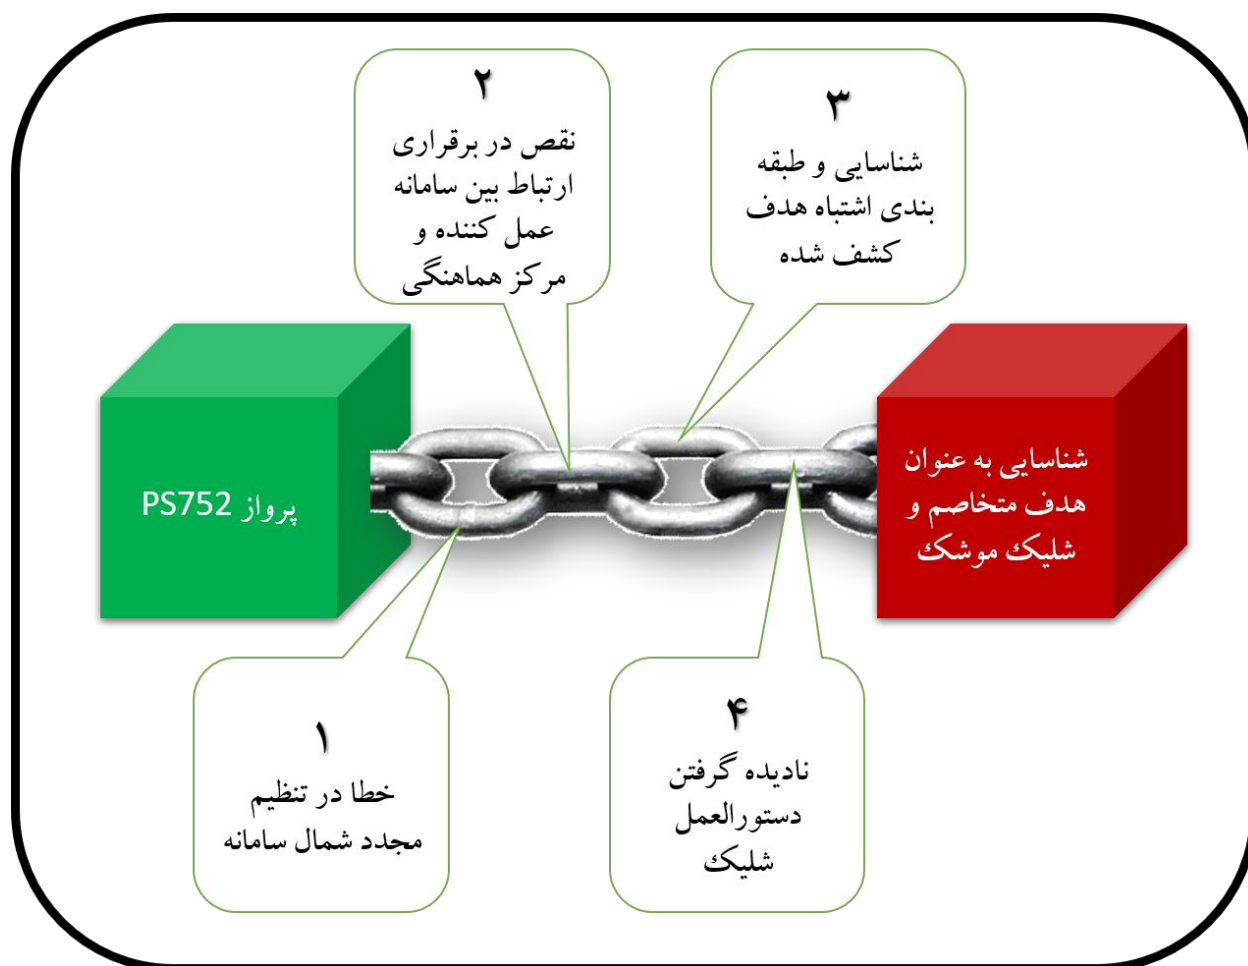
۱- سلسله رخدادها نشان از وقوع یک زنجیره رویداد با نقش پررنگ خطای انسانی<sup>۹</sup> است. تا این مرحله، حلقه‌هایی مؤثر از زنجیره رویدادهای منجر به شلیک اشتباهی موشک به هواپیما شناسایی شده است.<sup>۱۰</sup> زنجیره رخدادهای کلیدی شناسایی شده که در صورت حذف هر کدام، شلیک به سمت هواپیما رخ نمی‌داد در شکل ۸ قابل مشاهده است. با بررسی اطلاعات جعبه سیاه ممکن است برخی حلقه‌های جدید در سانحه شناسایی شود.

شکل ۸- زنجیره رخدادهای شناسایی شده که منجر به شلیک موشک به سمت هواپیما شده است.

<sup>۱۰</sup> - در زمان ارائه این گزارش، اصلاحات انجام شده توسط بخش دفاعی کشور که بر روی هر بخش از زنجیره رویداد متمرکز شده است، نشان می‌دهد که احتمال رویداد مشابه تا حد عدم تکرار کاهش یافته و اکنون ایمنی لازم برای پروازهای تجاری کشور از منظر هدف گیری اشتباه مطابق شرایط عادی برقرار است.

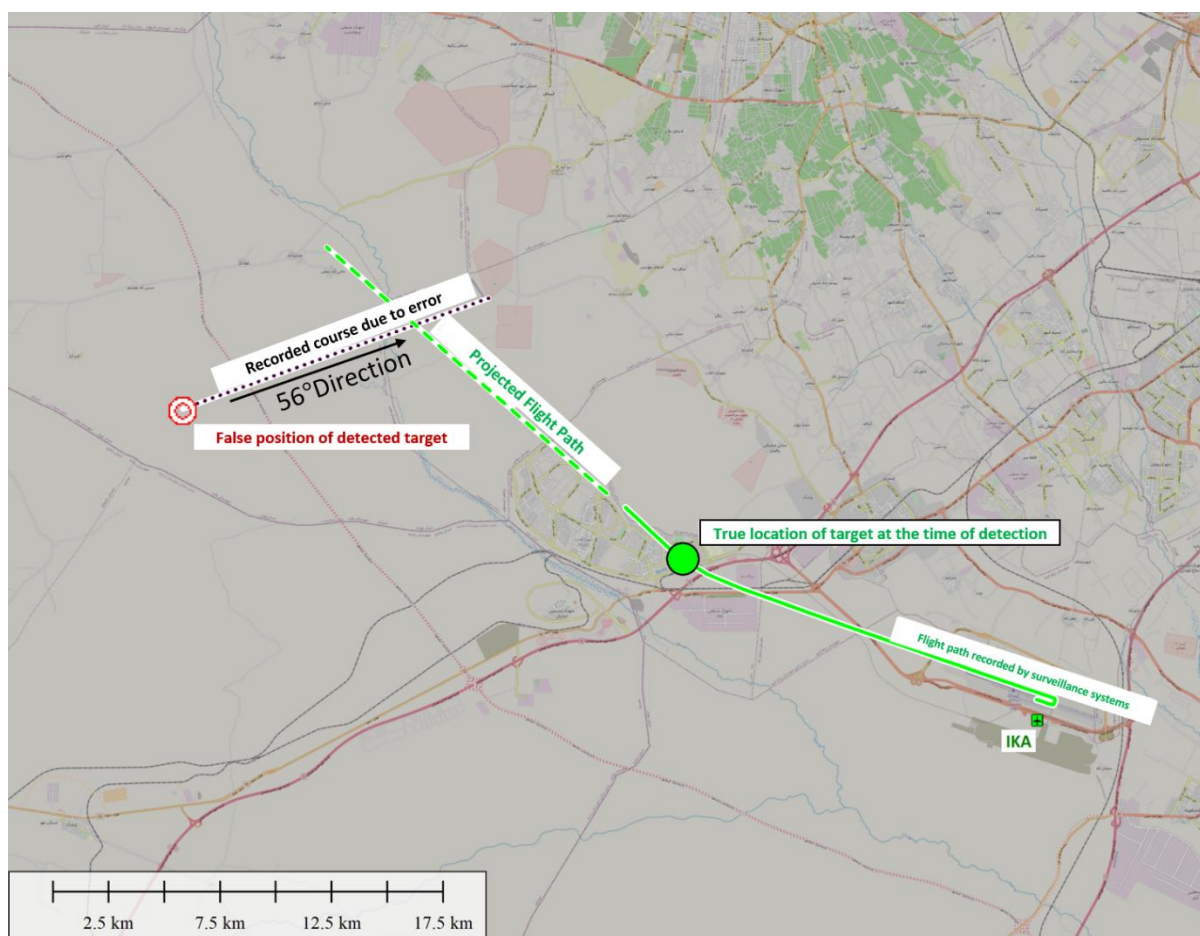
<sup>4</sup> After the relocation of one of the air defense units of Tehran, clearly causing a change in its heading, a failure occurred due to a human error in following the procedure of system north alignment. As a result, a 107-degree error was induced in the system. As such, while the PS752 aircraft was flying, the direction of objects and targets detected by this system was being observed with an increase

of 107 degrees by the operator. Such a functional failure initiated a hazard chain, which, of course, could be controlled providing other planned measures are implemented.

8. At 02:43:56, the air defense unit operator detected a target at his 250-degree azimuth, flying on a 52-degree course. At the same time, after takeoff, the PS 752 had been flying towards the defense system from a 143-degree azimuth. The aircraft was passing a 309-degree course.
9. At 02:44:21, the operator notified the specifications of the detected target to the Coordination Center over the communication network (note paragraph 10 on the communication status). The target was, in fact, the very PS 752 flight departing from IKA, detected by the system as a target approaching Tehran from approximately the southwest. (Figure 2)

Figure 2- The true location of the aircraft at the time of detection and the false location and course due to north alignment error

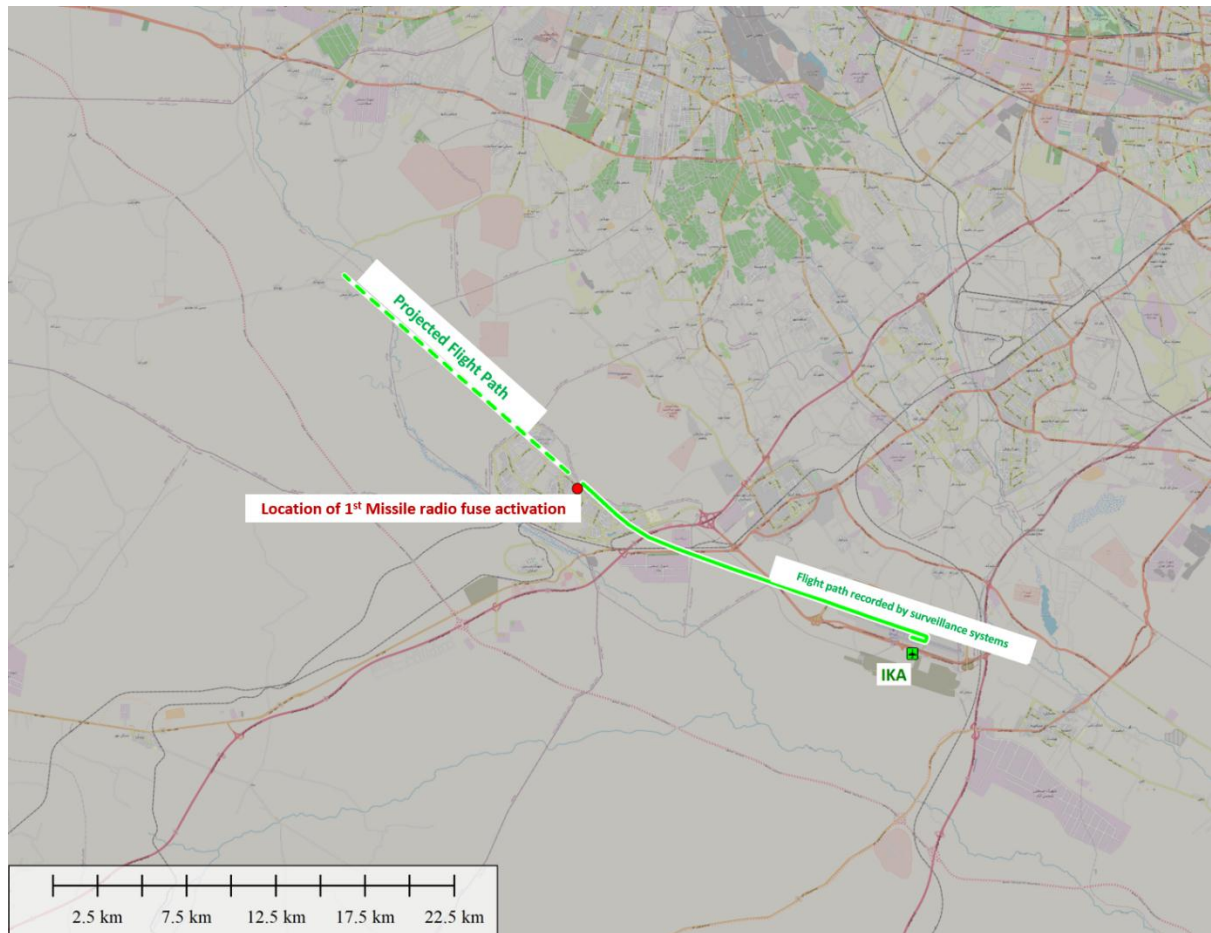
14. The missile radio fuse was activated when the aircraft had reached the last position recorded by the dependent surveillance systems<sup>6</sup>. The activation occurred at 02:44:59. (Figure 3)

Figure 3-The location of the first missile radio fuse activation

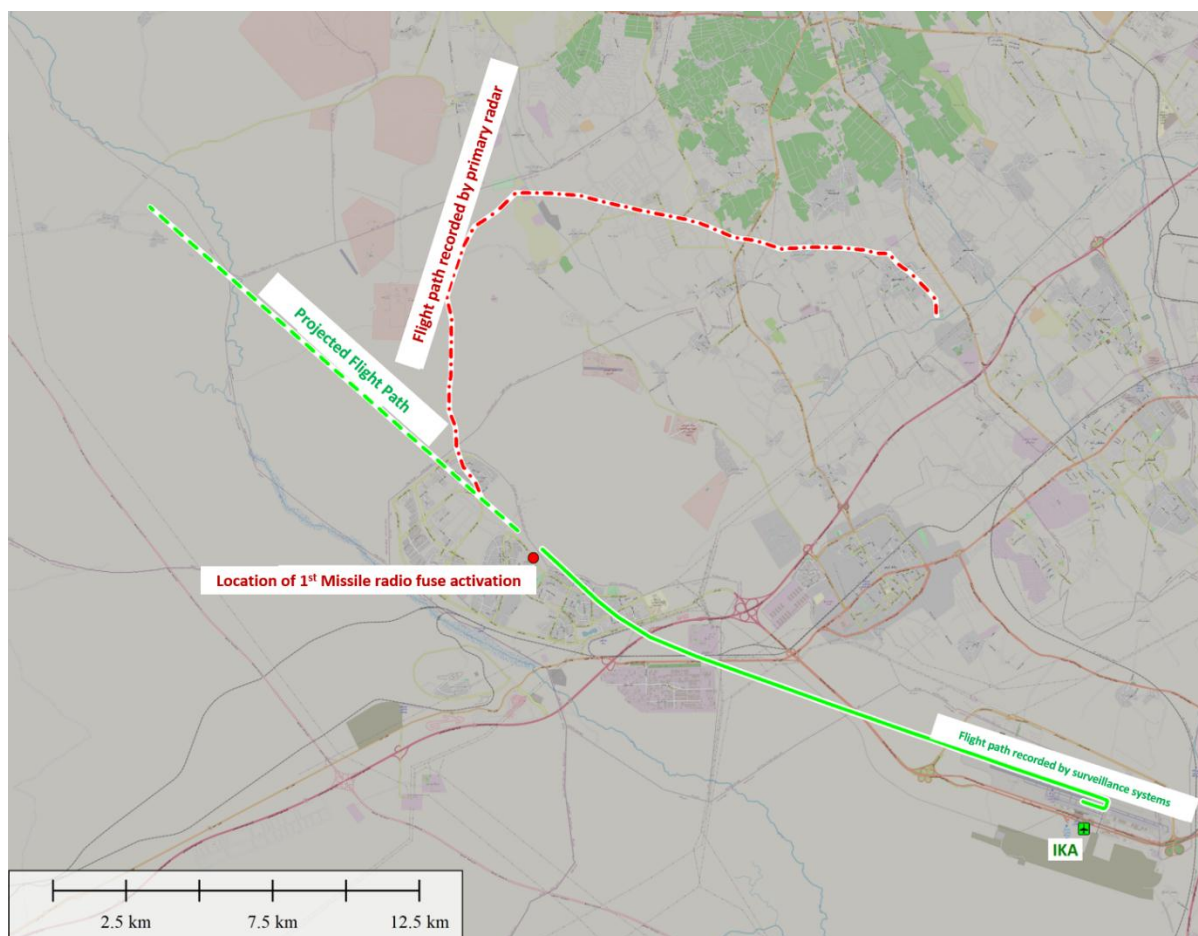
15. At 02:44:58, the last information received from the aircraft included the Secondary Surveillance Radar (SSR) transponder and Automatic Dependent Surveillance-Broadcast (ADS-B), after which the receiving of such signals was terminated. This time corresponds to the first missile radio fuse activation. From then on, the aircraft position was only being recorded by the Primary Surveillance Radar (PSR). (Figure 4)

Figure 4- Termination of SSR/ADS-B signal and recording the remainder of the flight path by PSR

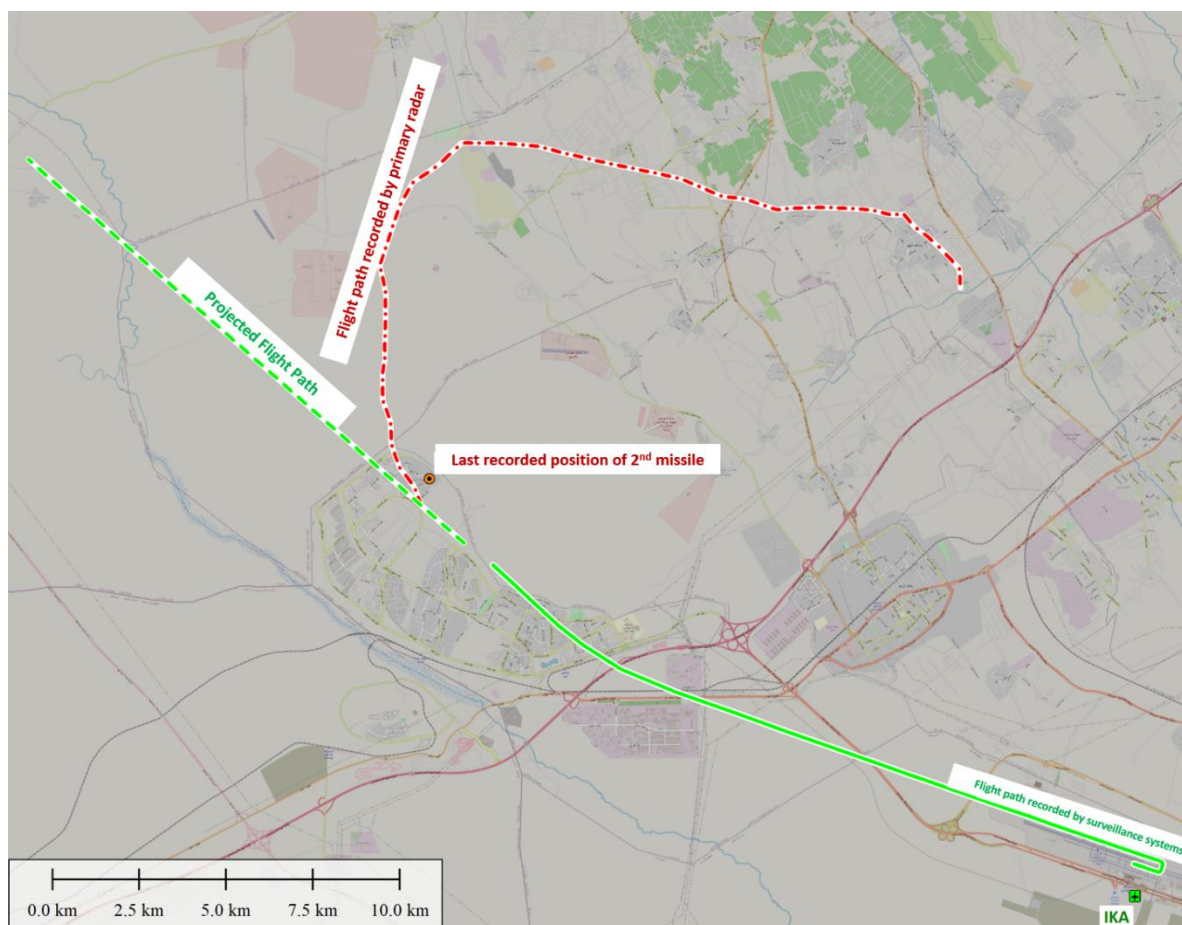
16. After the first missile radio fuse was activated, the air defense unit radar still locked on the target, and the defense system kept detecting and tracking it.
17. By observing the continuity of trajectory of detected target, the second missile was fired at the aircraft by the operator of defense system at 02:45:11.
18. At 02:45:24, the last communication between the missile and the defense system was recorded in a place close to the aircraft route. After that, the defense system showed a message indicating the strike had failed, with the aircraft clearing from the radar lock-on after some time. (Figure 5)

Figure 5- Last position recorded from 2<sup>nd</sup> missile by air defense unit

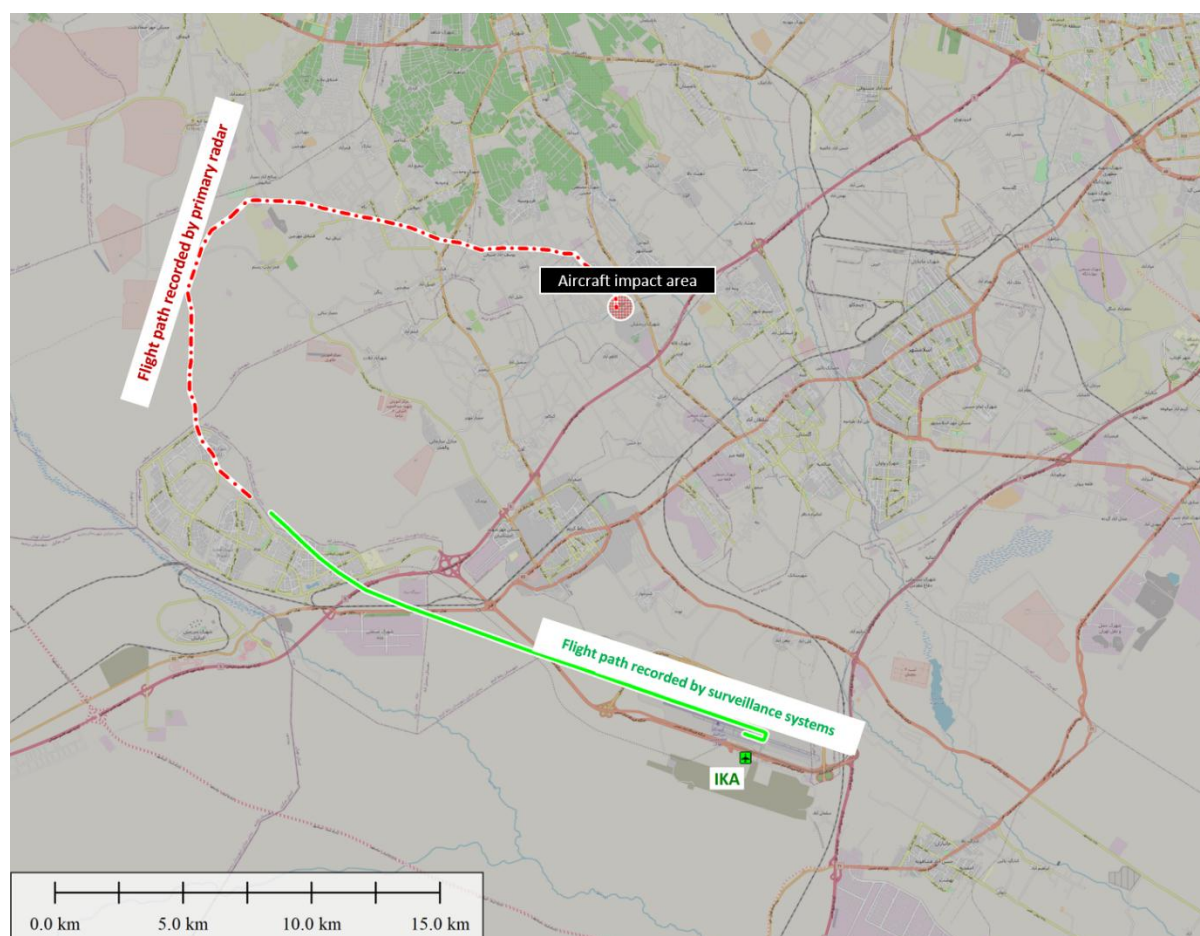
19. The aircraft turned to the right, the route of which can be seen in Figure 6. Due to the radio communication disconnection, there is no information on the aircraft altitude during the time when it was being detected by the Primary Surveillance Radar.
20. The evidence shows that at about 02:46:11, a fire broke out on the aircraft, which was intensifying.
21. At 02:48:23, the aircraft crashed into a playground in Khalajabad near Shahedshahr area at the location marked in Figure 6. An explosion occurred the moment the aircraft impacted the ground. The aircraft then kept hitting the ground and bouncing on a route towards the airport, making the aircraft pieces, victims' properties, objects and body remains disintegrate completely in a vast area near a residential complex, recreational and sports park, gardens and the surrounding agricultural land.

Figure 6- The aircraft impact area
